OPTIMAT BLADES

Preliminary tests Part 2

Static and fatigue tests of MD laminate with different gauge length

Research carried out by DLR within the framework of the Optimat Blades project
EC contract ENK6-CT-2001-00552

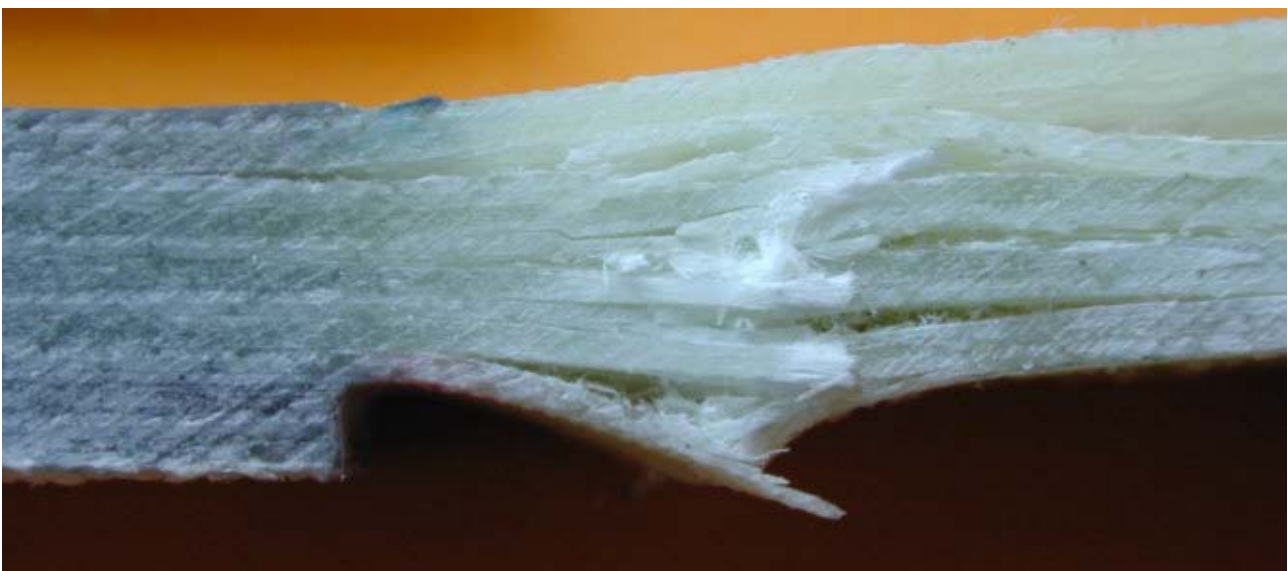
Figure 2: Specimen MD_S61_GL40

Test	F_{\max} [kN]	σ_{\max} [MPa]	ϵ_{\max} [%]	E [GPa]	Strain rate [%/s]	Cycles	Remarks
Compressive Tests							
S61_GL40	-85,34	-522,9	-1,95	27,66	≈0,031	-	Debonding of tabs, bending
S112_GL45	-82,54	-501,7	-2,00	29,90	≈0,043	-	Bending
Fatigue tests							
S66_GL40	±42,4	±261	+1,02 -0,95	+27,9 -25,9	10,0	168	Buckling
S71_GL40	±41,8	±261	+0,97 -0,75	+29,1 -31,8	5,0	336	Initial bending Severe buckling
S117_GL45	±32,89	±200	+0,79 -0,74	+27,4 -25,6	5,0	1897	Severe buckling

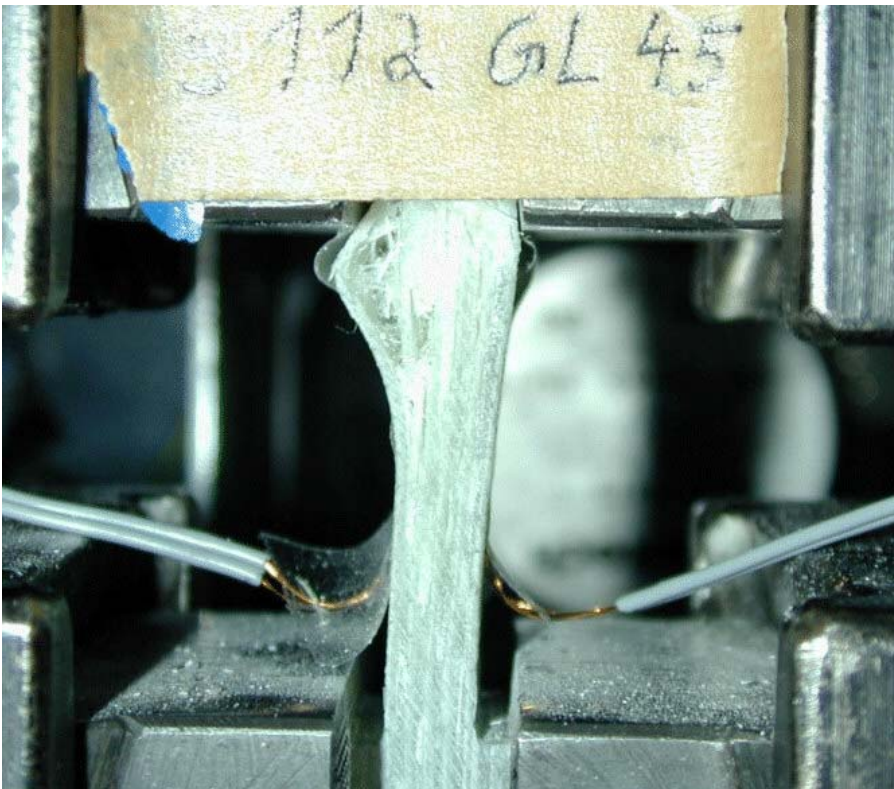
Figure 4: Specimen MD_S112_GL45

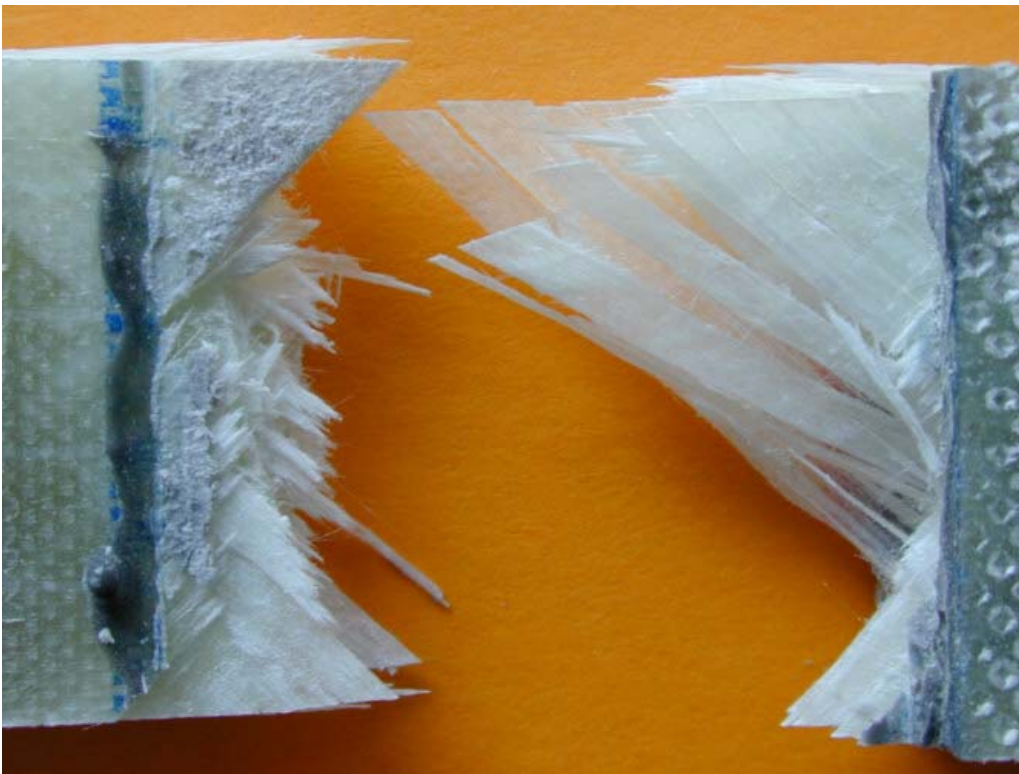
Figure 6: Specimen MD_S66_GL40

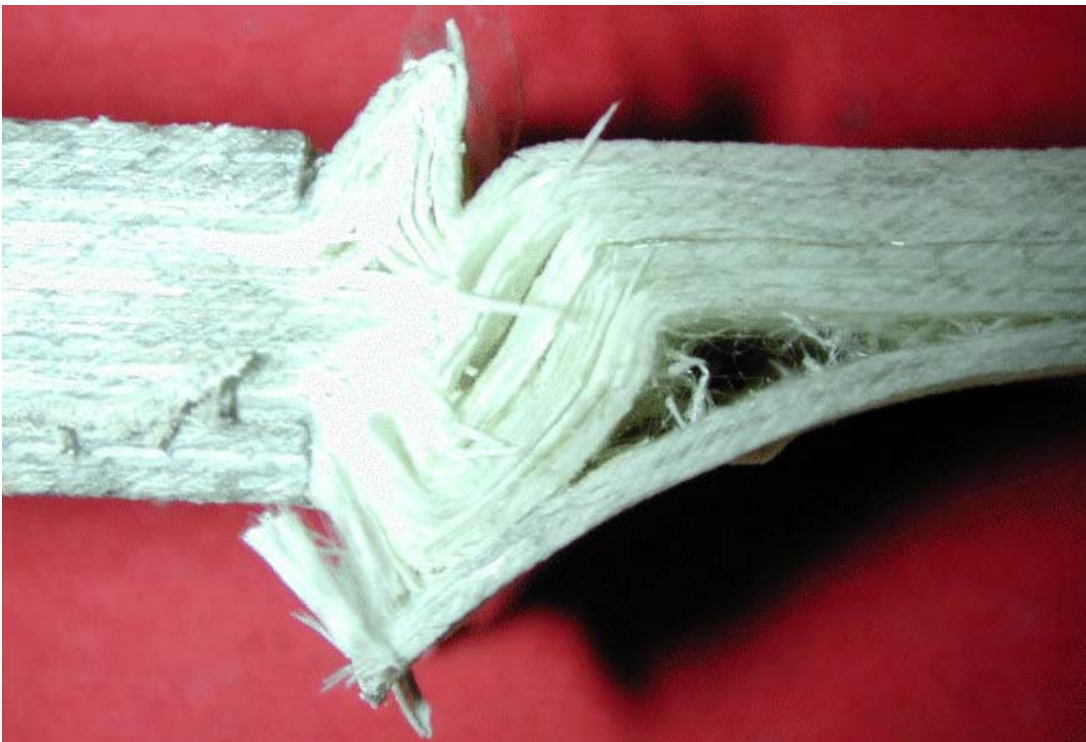
Figure 10: Specimen MD_S117_GL45

Since only a few specimen could be tested, the results don't allow any statistical evidence. But the presence of severe buckling for specimen MD_S117_GL45 already at a low stress level and low strain rate indicates that this gauge length is definitely too long.
