Preliminary test results of cruciform test specimens

OB_TG2_R007_VUB rev. 000

TG 2

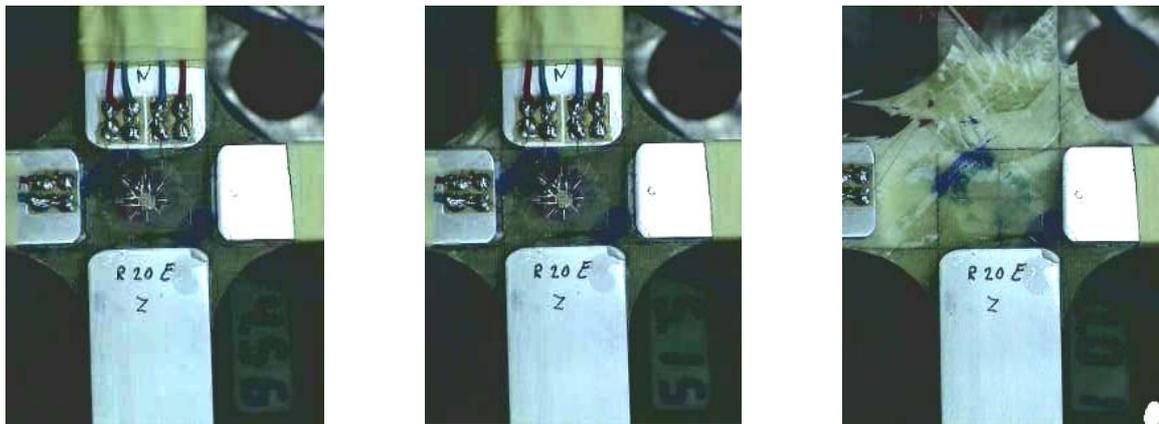
Figure 4: Photos of specimen R 20 E, Loading ratio=2.2/1.

Specimen R 20 E started failing near the intersection between the arms called north and west on the photos and after debonding of the end-taps in 0° direction at about 33kN and in the perpendicular direction at 41kN. Finally arm south was pulled off.

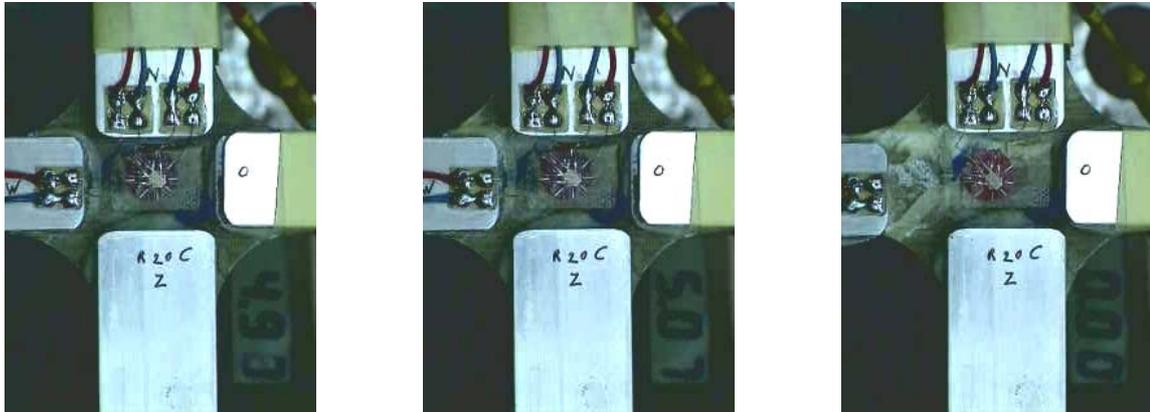
Figure 6: Photos of specimen R 20 C, Loading ratio=4.4/1.

For specimen R 20 C end-tap west debonded at a load of 32kN in the 0° direction and end-tap east at 37kN as can be seen on graph 4a as jumps in the strains. Then cracks between arm north and west occurred and finally arm west was broken.
